NASA Contractor Report 178246

Test Results for Composite Specimens and Elements Containing Joints and Cutouts

P. T. Sumida, R. C. Madan, and A. V. Hawley

Douglas Aircraft Company
McDonnell Douglas Corporation
Long Beach, CA 90846

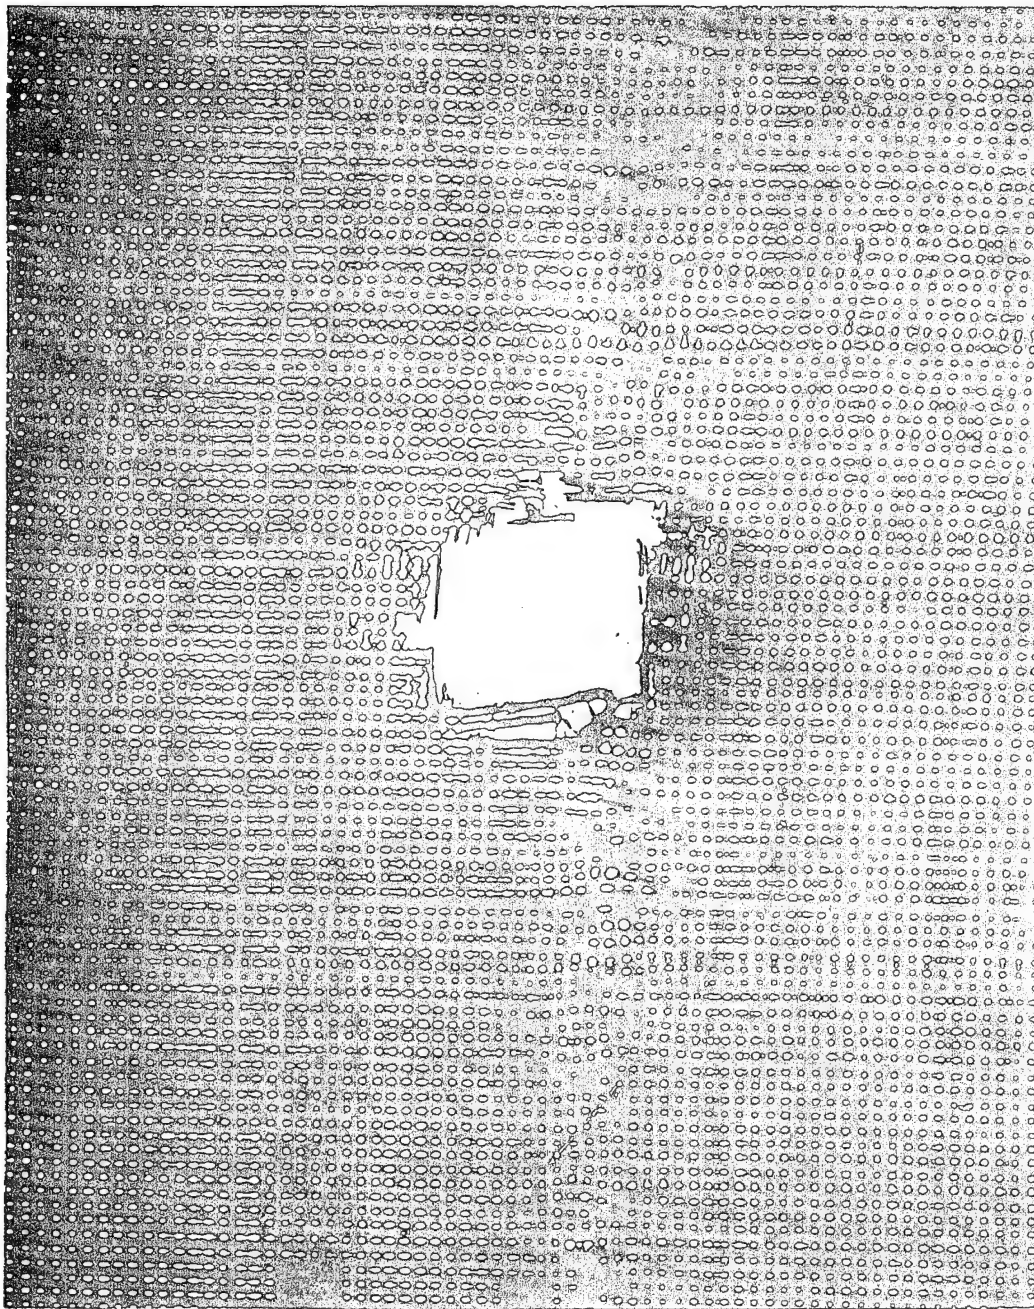
Figure 4-4. X-Ray of -505 CAI Specimen Showing Damage to Nickel-Coated Fibers

Table 4-1 gives actual discharge measurements for each of the specimens. Table 4-2 gives a detailed description of the damage sustained by each panel. The -505 panel (interwoven aluminum wire protection system) displayed the least damage (mainly top ply damage), while the unprotected panel displayed the most damage (penetration through all 12 plies). It should be noted here that the interwoven aluminum wire system was significantly thicker (cured thickness $\cong 0.021$ inch) than the nickel-coated graphite cloth system (cured thickness $\cong 0.011$ inch). X-ray photographs, showing the extent of damage to the nickel-coated fibers and the aluminum wires, are included for typical -505 and -507 panels in Figures 4-4 through 4-8.

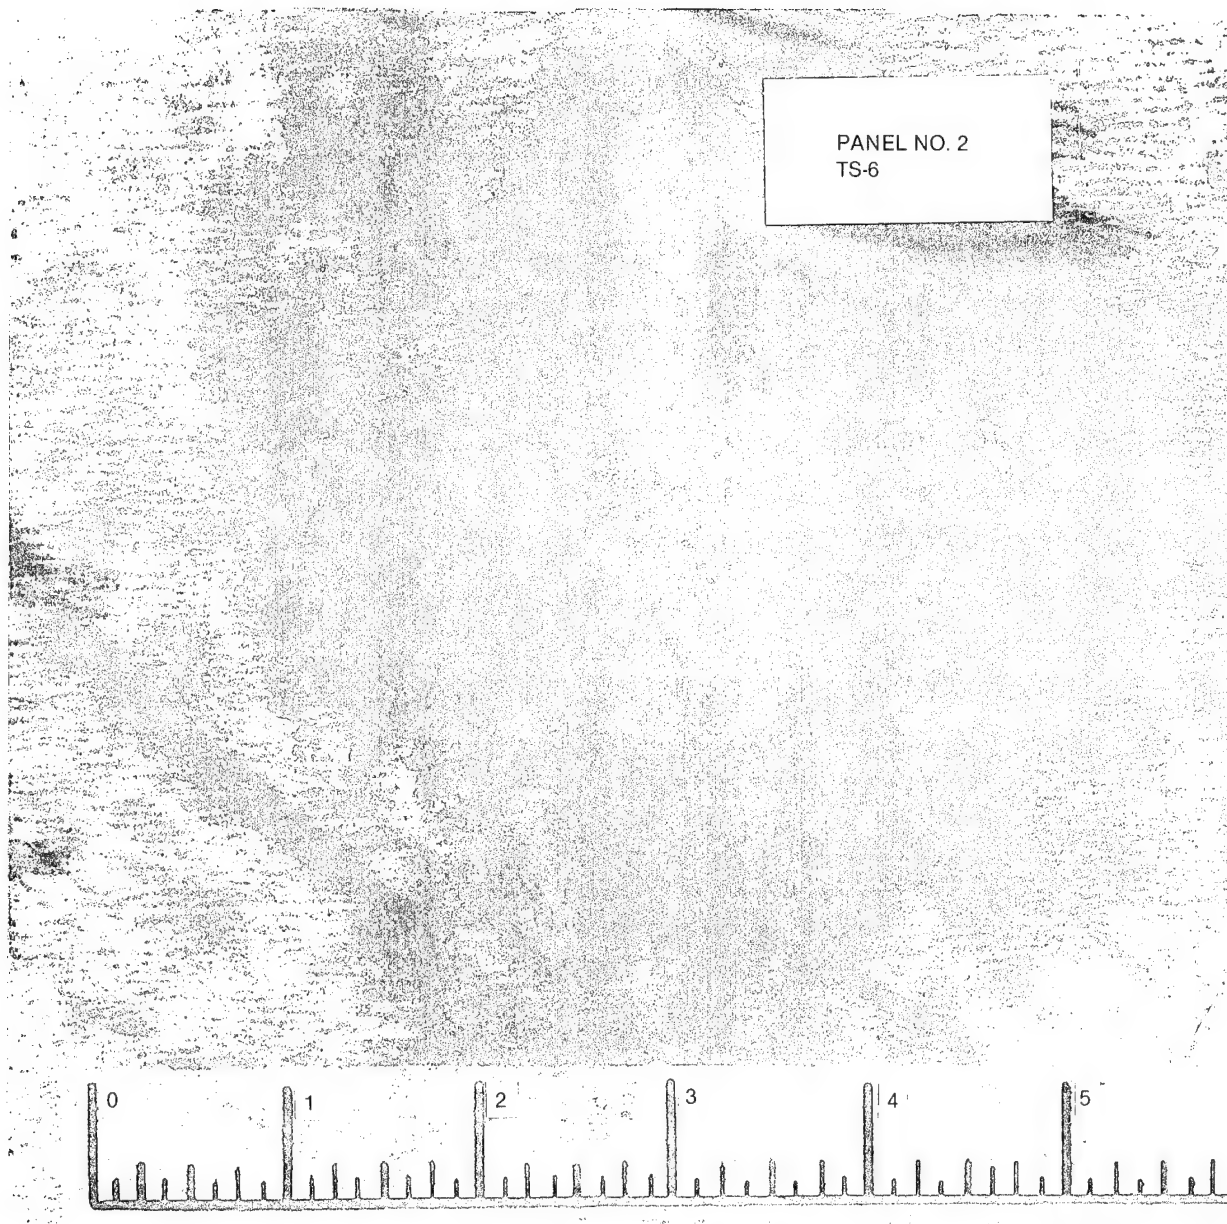
Figure 4-8. After Strike Damage on Unprotected Panel (UNC-509-3)

Although it was not actually one of the CAI specimens, it is interesting to compare the behavior of the calibration panel (unpainted, unprotected) to that of the -509 panel (painted, unprotected). The calibration panel displayed damage to the top 4 to 5 plies with no through-penetration (in fact, no visible damage to the back). This is contrasted with the -509 panel, in which all 12 plies were damaged and there was noticeable penetration. It is suspected that the paint layer has the effect of confining the energy of the strike, resulting in explosive damage.

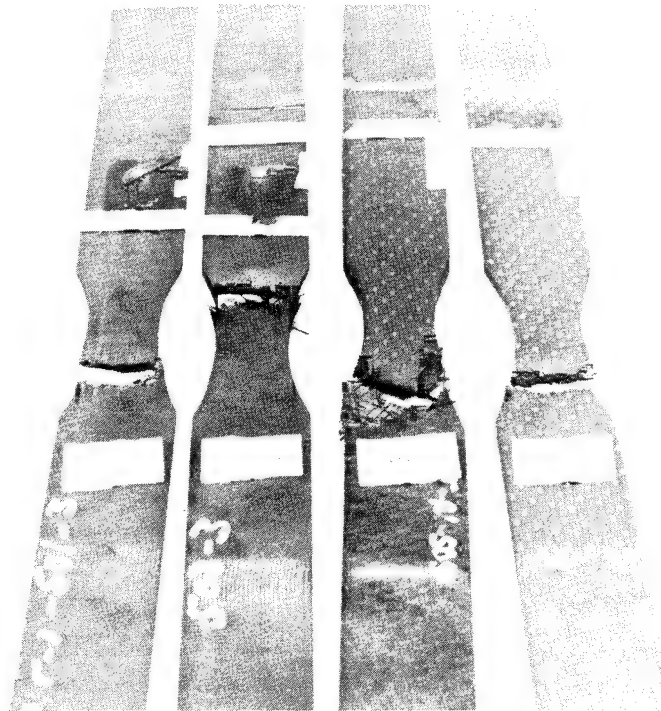
Figure 5-3. Failures of the Dogboned UNT Specimens

Two sets of unnotched tension specimens were fabricated and tested. The original specimens were "dog-boned" in an attempt to avoid failures at the grips of the test machine. None of these specimens, however, actually failed at the minimum cross section (Figure 5-3). The redesigned specimens were simply 7.50-inch by 1.12-inch strips with no dogbone or doublers. It was observed that there was only a slight increase in the ultimate tension strength of lay-ups No. 2, 3, and 4. Lay-up No. 1, however, showed a substantial increase in strength of just over 37 percent. In an attempt to reconcile this discrepancy, specimens from both sets were inspected for thickness, ply count, and ply orientation, but no anomalies were discovered.

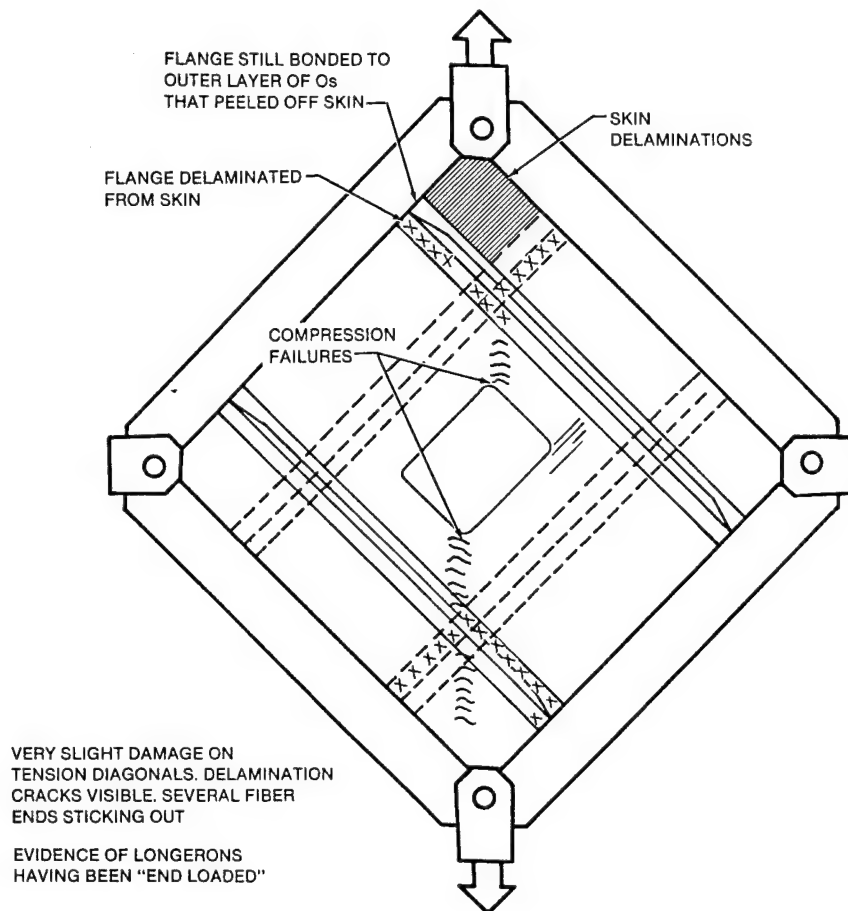
Figure 5-26. Failure Locations for -501 Shear Cutout Panel

As noted in Figure 5-26, there was also some very slight damage observed on the tension diagonals, as well as some slight brooming at the ends of the stiffeners, indicating that they had been end-loaded by the thick steel doublers bonded to the periphery of the panel. The loads carried by the latter, however, are not considered to have been significant.

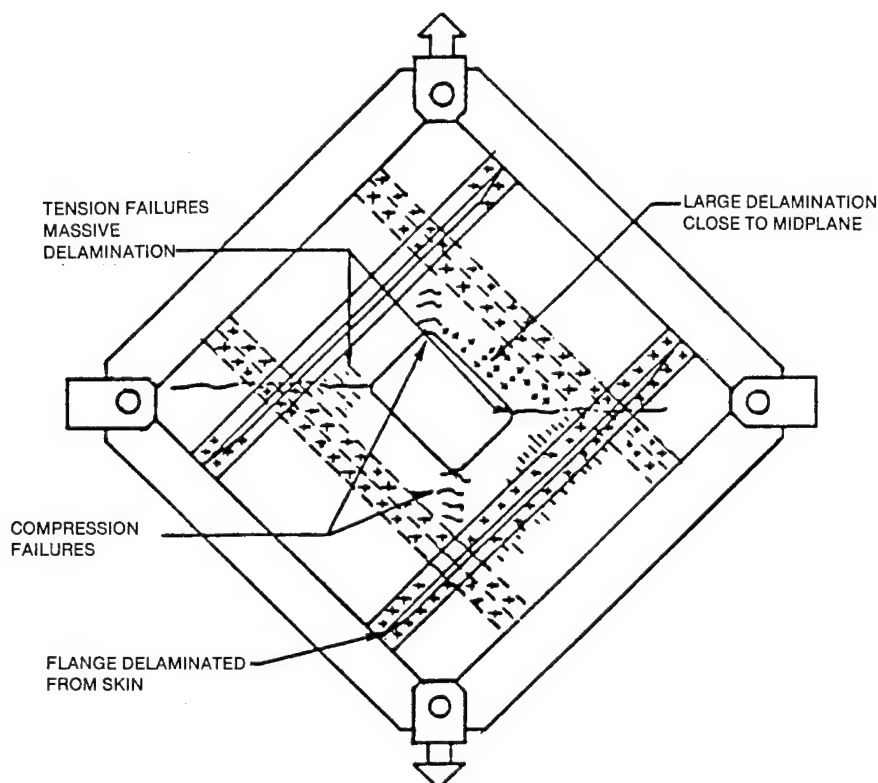
Figure 5-28. Failure Locations for -503 Shear Cutout Panel

Figure 5-28 is a sketch of the softened panel (-503) after failure. Strain gage data taken at the bottom corner indicate roughly linear behavior to about 60 kips. At 70 kips, measured strains at the bottom corner began to drop off rapidly with increasing load (down from $-11,629 \mu\text{in./in.}$ at 70 kips to $-5,360 \mu\text{in./in.}$ at 80 kips). Visual examination revealed very localized delaminations in both compression corners. These delaminations occurred on the side of the panel with the photoelastic film only a few layers from the outside surface. They were also located very close to the points of tangency of the corner radii to the straight sides. The load was then increased to 100 kips. Unlike the -501 (baseline) panel, very little growth of the delaminations was detected as the loads were increased to panel failure, which occurred at 121,110 pounds.

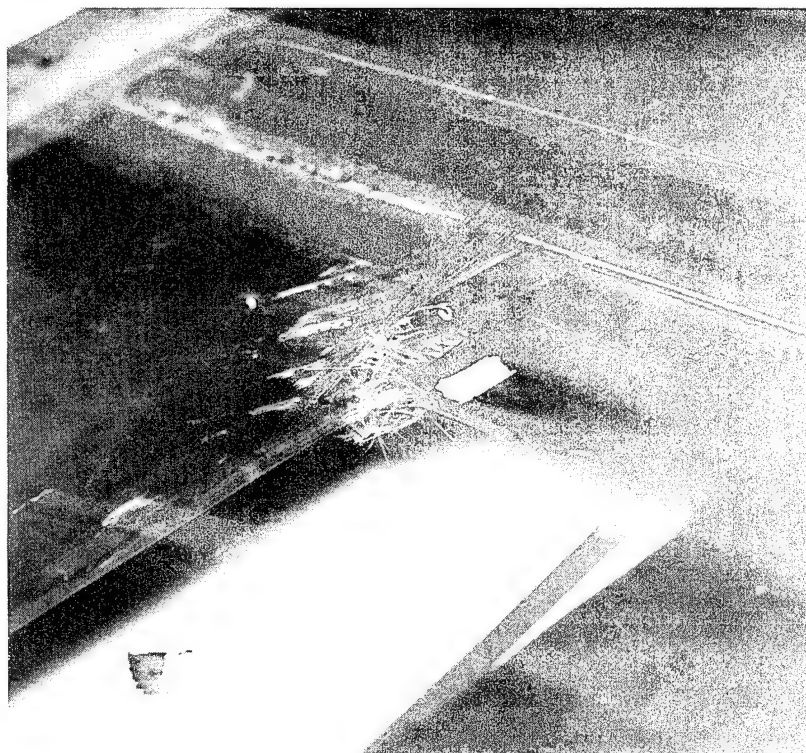
Figure 5-29. Posttest Photograph of Shear Cutout Panel (-505)

As previously noted, the ultimate failure of the -505 shear panel was precipitated by a partial failure of the test fixture. Strain gage data taken at the bottom (compression) corner indicated very low strains and became nonlinear very quickly (at about 30 kips). Photoelastic measurements indicated higher strains, which remained roughly linear over the range of loads surveyed (0-30 kips). Strain gage data taken at the left (tension) corner remained linear to about 60 kips. While holding the load at 70 kips, a loud noise was heard. Delaminations in both the compression corners were observed. At 108,900 pounds, the load fixture failed, loading the panel eccentrically and forcing a premature failure. Figure 5-29 shows stiffener separation (note the outer layer of 0s which peeled from the skin and are still attached to the stiffener) and the massive delaminations which occurred at the cutout.

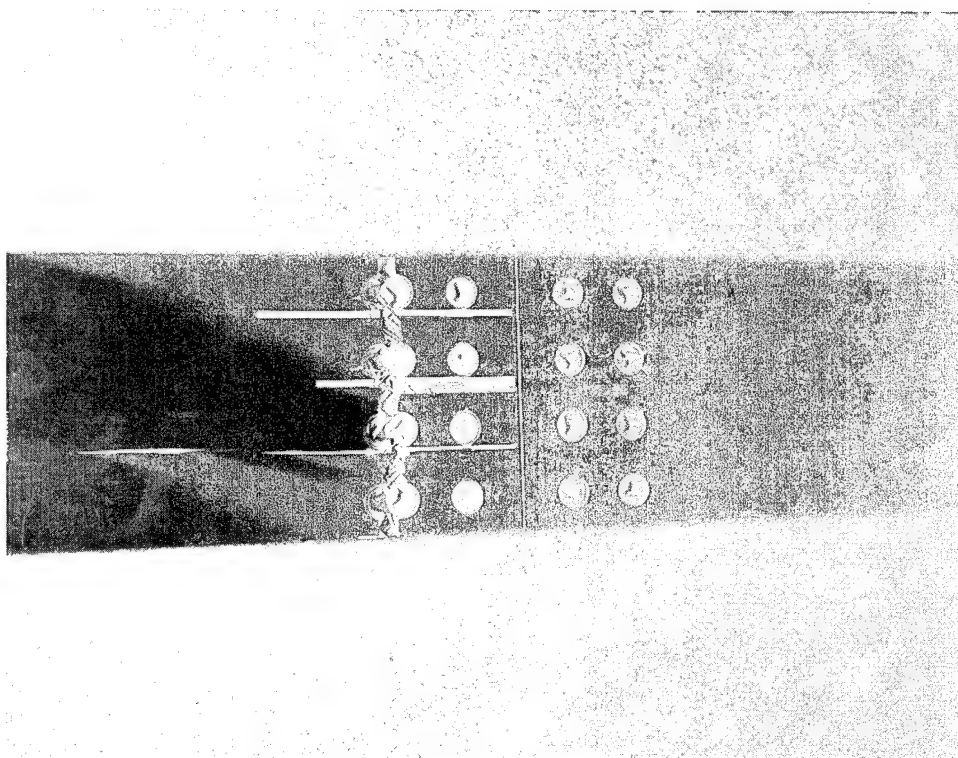
Figure 5-33. Failed Baseline Transverse Skin Splice Specimen

Figure 5-33 shows the failed baseline transverse skin splice specimen. The failure mode was net-section tension through the countersunk skin at one of the outermost rows of fasteners. Fastener rotation and bearing damage was minimal at the other three rows. This was typical of the two specimens assembled without sealant. The failed -1 specimen (assembled with sealant) appeared quite different, however. The ultimate failure apparently was partially tension through the outermost row of fasteners, and partially a combination of fastener failure and fastener pull-through. In addition, all four rows of fasteners exhibited significant fastener rotation with the accompanying bearing damage.

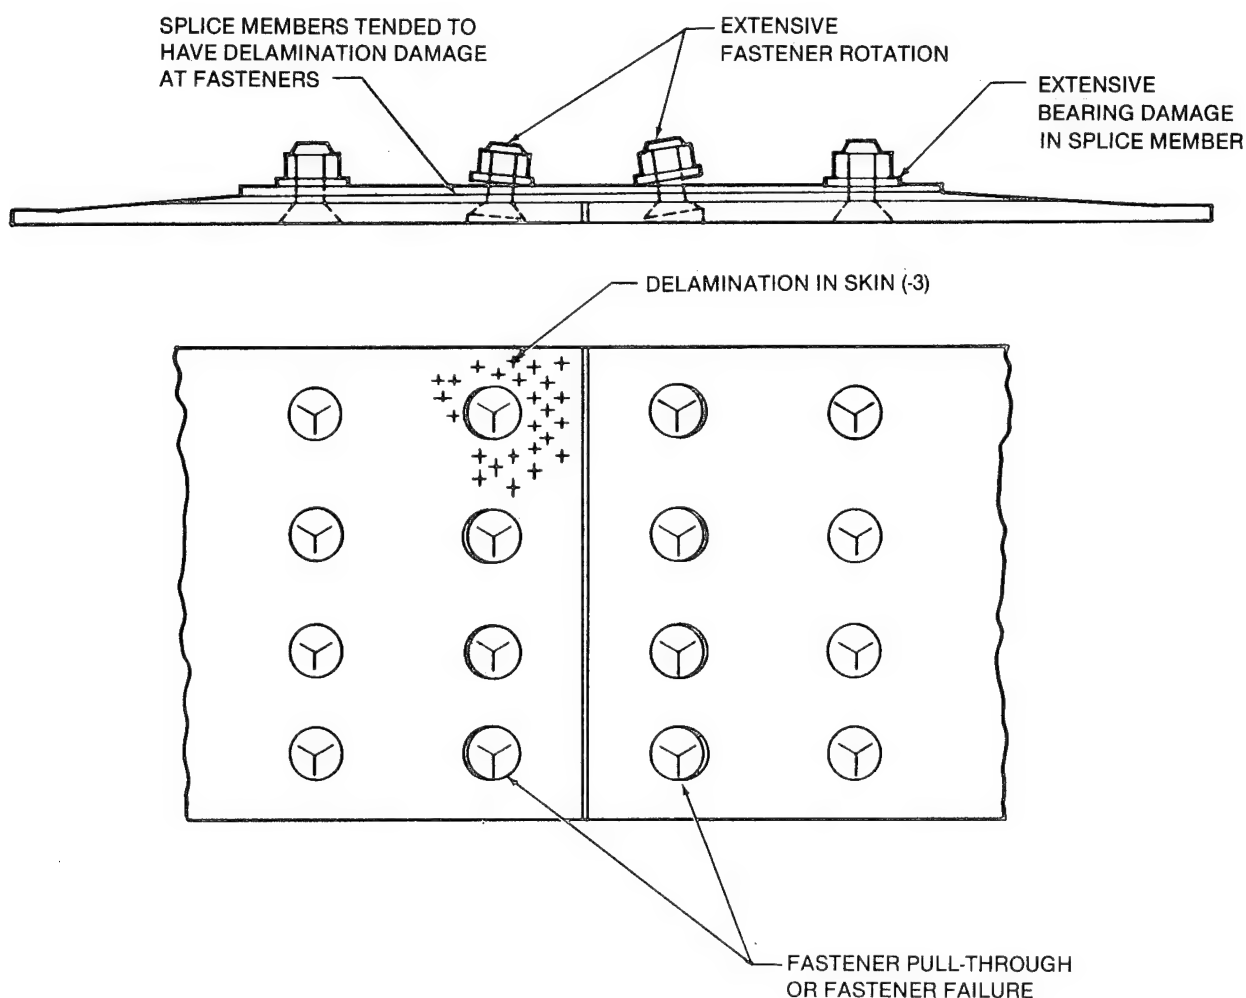
Figure 5-34. Failure Mode for Tailored Transverse Skin Splice Specimens

The presence of the sealant (for the -1 specimen) significantly reduced the strength of the tailored transverse splice specimen. The failure mode, for the most part, appears very similar to that of the -2 and -3 specimens (i.e., extensive bearing damage in the splice member at the outside rows of fasteners with the ultimate failure occurring at one of the inside rows due to fastener failure). Fastener failure for the specimens tested without sealant always occurred at the fastener head, through the tri-wing recess. Fastener failures for the -1 specimen, however, occurred at the opposite end near the first thread.

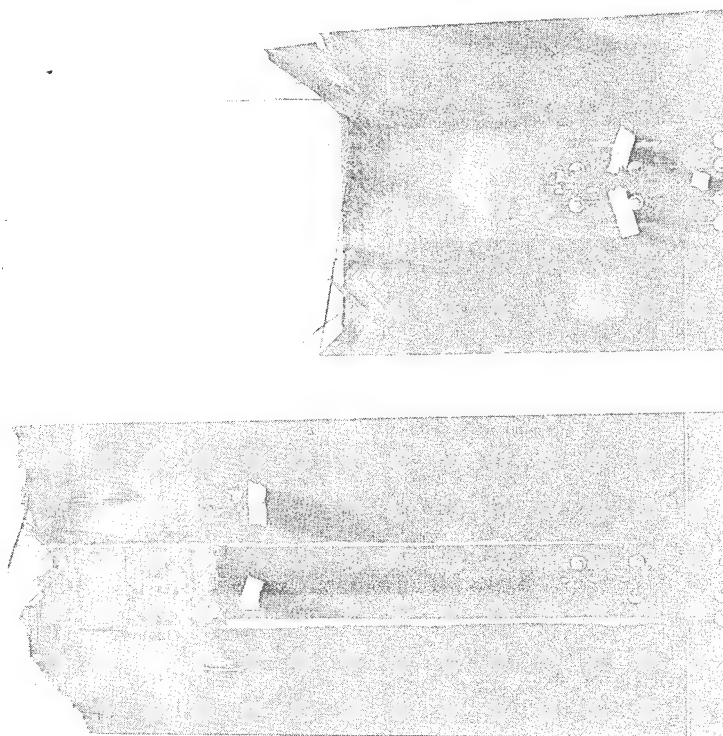
Figure 5-35. Failure of Longeron Runout Specimen

The longeron runout specimen failed at a tension load of 85,140 pounds. This corresponds to a running load of 8,514 lb/in. and a gross-section failure strain (P/EA at the center of the panel) of almost 11,000 $\mu\text{in./in.}$ Figure 5-35 shows the failed specimen. Three failure locations are noted: one through the skin before the thickness increase, and two through the stiffener. The stiffener failures were (1) at the first row of bolts tying the stiffener to the end clips, and (2) at the center of the panel. It is obvious that the stiffener separated from the skin because the failure locations were different for the two elements. The ramp angle where the skin buildup occurs (close to the net-section skin failure) could have contributed to this delamination.

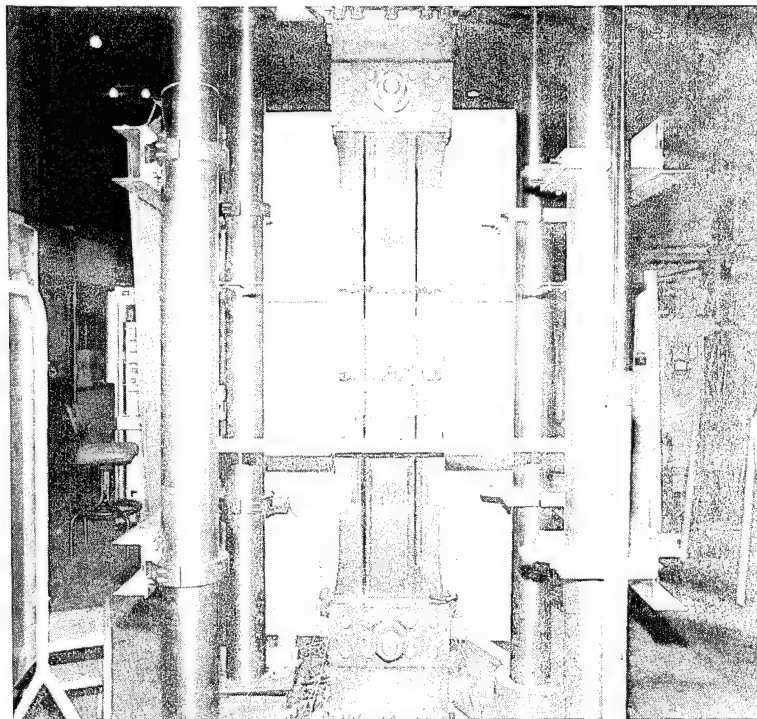
Figure 5-38. Longeron/Skin Splice Panel (Compression Specimen) Under Load

Figure 5-38 shows the compression panel during testing at roughly limit load with the skin buckling evident just "outside" of the splice bay (above and below the simulated frame supports).

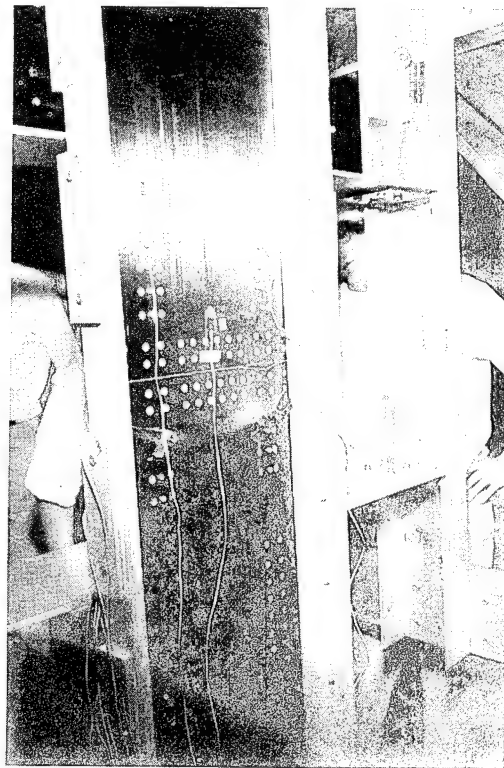
Figure 5-39. Failure of Longeron/Skin Splice Panel (Compression Specimen)

The second of the two-stiffener longeron/skin splice panels was tested in compression and failed at 46,310 pounds. This corresponds to a running load of 3,336 lb/in. and a gross-section failure strain (P/EA away from the joint) of approximately 3,000 $\mu\text{in./in.}$ Like the tension test, strain gage data as well as visual observations indicated a considerable amount of bending and nonlinear behavior. Edge deflections for this panel were limited, however, by the special fixturing. Nevertheless, the maximum transverse displacements appeared to be at the panel edges. Unlike the tension test, strain gage data indicated virtually no eccentricity in the stiffener splice (equal strains in the Z and L splice members).
